# Scene 7 · MS4 Assessment

Black Branch 2

City of Lebanon TN

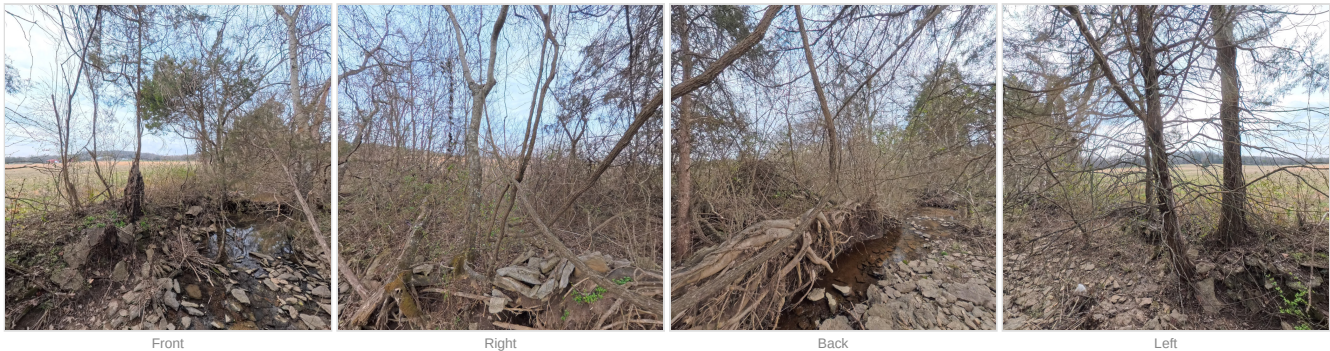
**Front:** Looking downstream, a narrow stream channel is visible with very low flow winding through exposed flat rock substrate. The left bank shows agricultural fields beyond a thin riparian corridor. Trees are leafless with some Eastern red cedars providing evergreen cover. Flat, angular rock pieces line the bank and channel bed.

**Right:** The right bank (left bank when facing downstream) shows a steep, densely vegetated slope with bare deciduous trees and thick understory brush. Flat limestone rock pieces are visible at the base of the bank where it meets the channel. The slope rises moderately with dense tangled vegetation including vines and shrubs.

**Back:** Looking upstream, the channel continues as a narrow, shallow stream with very low flow over exposed limestone bedrock and cobble substrate. A large fallen tree with extensively exposed root mass spans near the channel, indicating significant bank erosion and undercutting. Dense riparian vegetation lines both banks with bare deciduous trees and some cedars.

**Left:** The left bank (right bank when facing downstream) shows trees at the bank edge with an open agricultural field visible beyond. The riparian buffer is very narrow, perhaps only 10-30 feet wide with scattered trees and shrubs before giving way to open cropland. Flat limestone rock pieces are visible along the bank toe. A red structure or vehicle is visible in the distant agricultural landscape.

Black Branch at this location is a small, headwater stream in marginal condition, classified as a Rosgen F-type entrenched channel with active bank erosion and moderate incision. The most significant issues are the inadequate left bank riparian buffer adjacent to agricultural fields (less than 30 feet, below TDEC minimum), active mass bank failure evidenced by fallen trees with exposed root systems, and disconnection from the historic floodplain. Water quality appears fair at current low flow conditions with no evidence of illicit discharge, but the narrow buffer and adjacent agricultural land use pose ongoing risks for sediment and nutrient loading. No stormwater infrastructure or outfalls were observed in this reach.

| Side | Stability | Veg. Protection | Erosion | Notes |
|---|---|---|---|---|
| Left | 4 | 4 | 26_50_percent | Left bank transitions quickly from stream to agricultural field with a narrow riparian corridor of 10-30 feet. Active erosion is visible at the bank toe. Some trees showing root exposure. The narrow buffer is insufficient for long-term bank stability given the agricultural land use. |
| Right | 3 | 5 | 26_50_percent | Right bank shows more severe erosion than left bank, with evidence of mass wasting including fallen trees with exposed root systems. The bank is steeper and taller on this side, suggesting the stream is actively migrating laterally. Dense understory vegetation provides some resistance but is being undermined. |

| Metric | Score/Value | Notes |
|---|---|---|
| TDEC 30ft Buffer Met? | L: No / R: Yes | Left bank buffer is non-compliant with TDEC MS4 permit section 4.2.5.4 minimum 30ft riparian buffer requirement. Agricultural field cultivation extends to within approximately 10-25 feet of the stream bank. Buffer restoration on the left bank should be a priority. The right bank buffer appears to meet minimum requirements. |

| Action | Priority | Timeline |
|---|---|---|
| Document left bank riparian buffer deficiency for TDEC MS4 buffer compliance records | high | 30_days |
