# Scene 8 · MS4 Assessment

Black Branch 2

City of Lebanon TN

36.17007, -86.26864 · Generated October 23, 2026

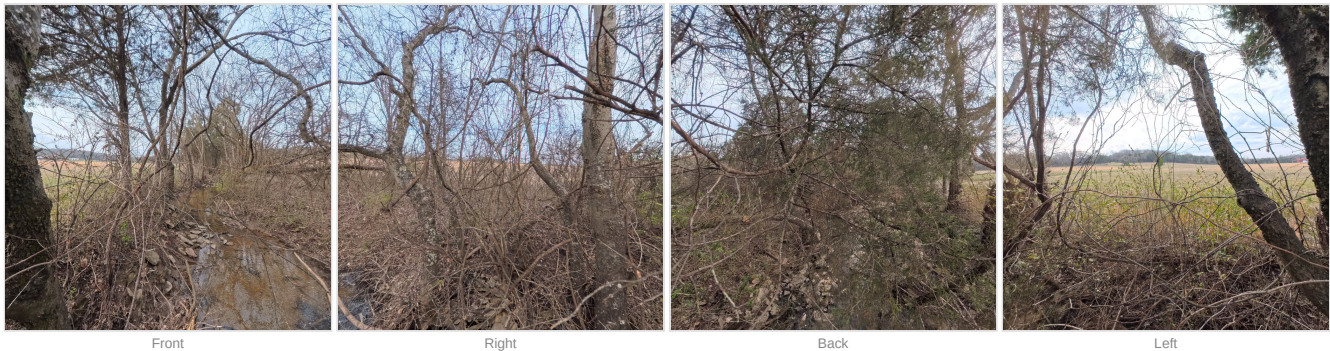
**Front:** Looking downstream along a narrow, shallow creek channel bordered by bare deciduous trees and dense shrubby undergrowth. The channel has flat rock/slab substrate visible along the left bank edge with shallow water flowing over a mud/silt bed. Agricultural fields are visible in the background through the bare trees on the left side.

**Right:** Dense thicket of bare deciduous shrubs and small trees forming the right bank riparian zone. The vegetation is dormant but provides dense structural cover. Behind the riparian strip, agricultural pasture/field land is faintly visible through the vegetation. No water or channel features are directly visible in this direction.

**Back:** Looking upstream, the view shows dense riparian vegetation including what appears to be eastern red cedar (evergreen) and bare deciduous trees forming a tight canopy. Below, the narrow channel is partially visible with flat rock slabs along the bank edge and shallow water. The dense cedar/evergreen vegetation provides year-round cover on this bank.

**Left:** Looking toward the left bank (facing downstream), the view opens to a broad, flat agricultural field/pasture. A narrow strip of riparian trees and shrubs borders the stream, with open grassland extending several hundred feet to a distant red agricultural building/barn. The riparian buffer on this side appears quite narrow, transitioning quickly to mowed or grazed pasture.

Black Branch at this location is a small, low-gradient headwater stream flowing through an agricultural landscape near Lebanon, Tennessee. The stream shows marginal overall condition with primary impairments from excessive fine sediment deposition, a critically narrow left bank riparian buffer, and moderate channel incision disconnecting the stream from its floodplain. The right bank has a wider, denser riparian buffer that provides some stream corridor functions, while the left bank transitions abruptly from a thin tree line to open agricultural pasture. No stormwater infrastructure or outfalls were observed at this rural location, and no illicit discharge indicators were detected. Habitat for aquatic life is significantly limited by the silt-dominated substrate and lack of pool-riffle structure.

| Metric | Score | Notes |
|---|---|---|
| Channel Condition | 6 | Channel appears natural with no direct engineering modifications, but shows evidence of moderate incision likely resulting from land use changes in the watershed. The channel is cut below the floodplain level with moderate bank heights (3-6ft), suggesting some downcutting has occurred. No riprap, concrete, or channelization present. |
| Hydrologic Alteration | 5 | Moderate channel incision visible with banks 3-6ft high relative to the small channel width. The stream appears disconnected from its floodplain, with the agricultural field surface well above the bankfull stage. This incision is likely related to increased runoff from agricultural land use changes. Flooding of the adjacent fields appears infrequent. |
| Sediment Deposition | 4 | The channel bed is predominantly silt/mud, indicating significant fine sediment deposition. The original gravel/cobble substrate appears largely buried. Estimated 30-50% of bottom affected by fine sediment deposition. This is consistent with agricultural runoff from adjacent fields contributing sediment load. Some natural limestone fragments remain exposed but much of the bed is embedded. |

| Side | Stability | Veg. Protection | Erosion | Notes |
|---|---|---|---|---|
| Left | 5 | 4 | 26_50_percent | Left bank has a critically narrow riparian buffer between the stream and active agricultural fields. The transition from streambank vegetation to open pasture is abrupt, indicating potential for agricultural runoff to reach the stream with minimal filtering. No fencing visible to restrict livestock access, though no direct evidence of livestock in the stream was observed. |
| Right | 6 | 6 | 1_25_percent | Right bank benefits from wider and denser riparian vegetation including eastern red cedar which provides year-round cover. Agricultural fields are visible beyond the riparian strip but the buffer appears wider than on the left bank. The dense shrub thicket provides good bank stability. |

| Metric | Score/Value | Notes |
|---|---|---|
| Canopy Cover | 5 | During winter leaf-off, canopy cover is reduced. The bare deciduous trees and scattered eastern red cedars provide approximately 25-50% shade. During summer with full leaf-out, coverage would likely increase to 50-75%. The sycamore and other deciduous trees provide the primary shade but the narrow buffer limits canopy closure, especially on the left bank. Scoring reflects year-round average condition. |
| TDEC 30ft Buffer Met? | L: No / R: Yes | The left bank buffer is critically narrow with agricultural pasture encroaching close to the stream bank. Buffer restoration through planting and fencing to exclude livestock/mowing from the riparian zone would significantly improve conditions. The right bank buffer is adequate but could benefit from enhancement to 60ft width. No fencing observed to delineate or protect riparian buffers on either bank. |

| Metric | Score | Notes |
|---|---|---|
| Water Appearance | 5 | Water has a brown tint consistent with tannic/organic coloration and some suspended fine sediment. Clarity appears moderate — the bed is visible through the shallow water but color limits deeper visibility. No oil sheen, foam, or algal mats visible. The brown color is likely a combination of natural organic inputs and fine sediment suspension from the silt bed. No obvious surface contamination. |

| Action | Priority | Timeline |
|---|---|---|
| Conduct outfall mapping survey of the broader reach to identify any agricultural drainage inputs or tile drains entering the stream | medium | 90_days |
| Complete visual stream survey documentation for this reach as part of MS4 comprehensive stream assessment program | medium | annual |
