# Scene 9 · MS4 Assessment

Black Branch 2

City of Lebanon TN

36.17007, -86.26867 · Generated October 23, 2026

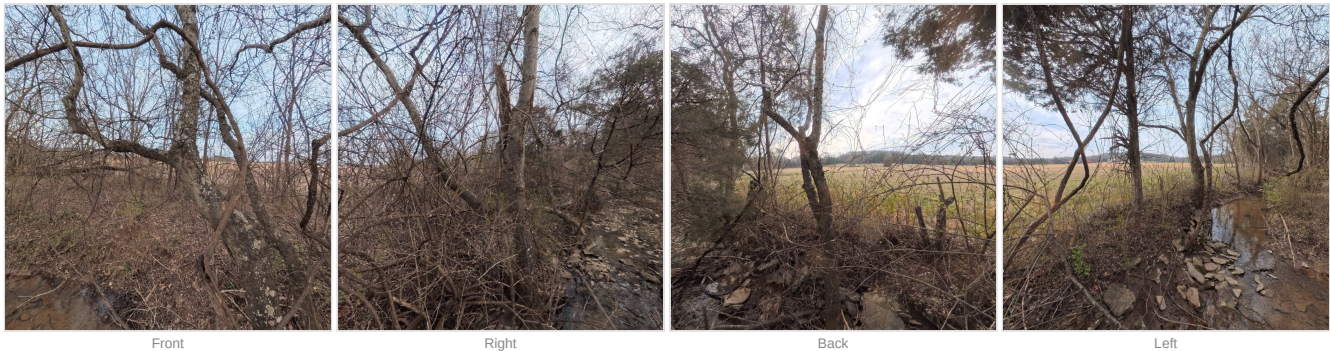
**Front:** Looking downstream, the view shows dense deciduous trees and shrubs, all bare of leaves in winter condition. The ground is covered with leaf litter and dead herbaceous vegetation. Through the trees, a building or structure with a reddish-brown facade is partially visible in the background, suggesting nearby development. The bank drops off to the left where the channel appears to be located.

**Right:** Looking toward the right bank (facing downstream), dense bare deciduous trees and tall shrubs dominate. A large sycamore tree trunk is prominent. The channel bed is partially visible at lower right with what appears to be flat rock or flagstone substrate. The bank is steep and covered with dense vine and shrub growth. A steep wooded hillside rises beyond the immediate riparian area.

**Back:** Looking upstream, the view opens to reveal an agricultural field or pasture extending into the distance beyond a thin riparian buffer. A few bare deciduous trees and some evergreen (likely eastern red cedar) trees line the bank. The stream channel and rocky substrate are visible at the bottom of the frame. Open agricultural land is clearly visible through the sparse winter vegetation, indicating minimal riparian buffer on at least one side.

**Left:** Looking toward the left bank, a small stream channel is clearly visible with shallow water flowing over a rocky substrate of flat limestone/shale. The left bank has a thin riparian buffer of bare deciduous trees and eastern red cedar, beyond which open agricultural/pasture land extends. A red structure (possibly a barn) is visible in the far distance. The flat rock substrate in the channel is consistent with natural limestone bedrock formation. The riparian buffer is very narrow on this side, perhaps only 10-30 feet before transitioning to open pasture.

Black Branch at scene #9 is a small, shallow headwater stream flowing over limestone/shale bedrock in a rural agricultural setting near Lebanon, Tennessee. The stream is marginally impaired, with primary concerns being an inadequate riparian buffer on the left bank where agricultural land extends within 10-25 feet of the channel, limited instream habitat diversity due to bedrock substrate dominance and absence of large woody debris, and minimal pool development. The right bank has a more robust forested buffer extending 50-100+ feet. No stormwater infrastructure, outfalls, or illicit discharges were observed. Water quality appears fair with no obvious contamination. The most actionable management recommendation is riparian buffer restoration on the left bank to improve shade, bank stability, habitat inputs, and filtering of agricultural runoff.

| Side | Stability | Veg. Protection | Erosion | Notes |
|---|---|---|---|---|
| Left | 5 | 5 | 26_50_percent | Left bank has a very narrow riparian buffer (estimated 10-30 feet) before transitioning to open agricultural/pasture land. Bank is low but showing moderate erosion. The proximity of agricultural land use is the primary concern for this bank. |
| Right | 6 | 7 | 1_25_percent | Right bank is steeper but better vegetated and more stable than the left bank. Wooded hillside extends well beyond the riparian zone providing excellent buffer on this side. The asymmetry between left and right bank conditions is notable. |

| Metric | Score/Value | Notes |
|---|---|---|
| TDEC 30ft Buffer Met? | L: No / R: Yes | The left bank buffer is the primary concern. Agricultural/pasture land extends within the 30-foot buffer zone on the left bank. This is a high-priority area for buffer restoration through riparian planting. The right bank buffer meets TDEC standards. |

| Action | Priority | Timeline |
|---|---|---|
| Document narrow riparian buffer condition on left bank for watershed management planning | medium | 90_days |
